Goal: Trial the Beneficial Use of Dredged Material to Restore Salt Marshes

Original plan: thin-layer placement of dredged material over salt marshes that were threatened by sea level rise.

Regional Site Identification

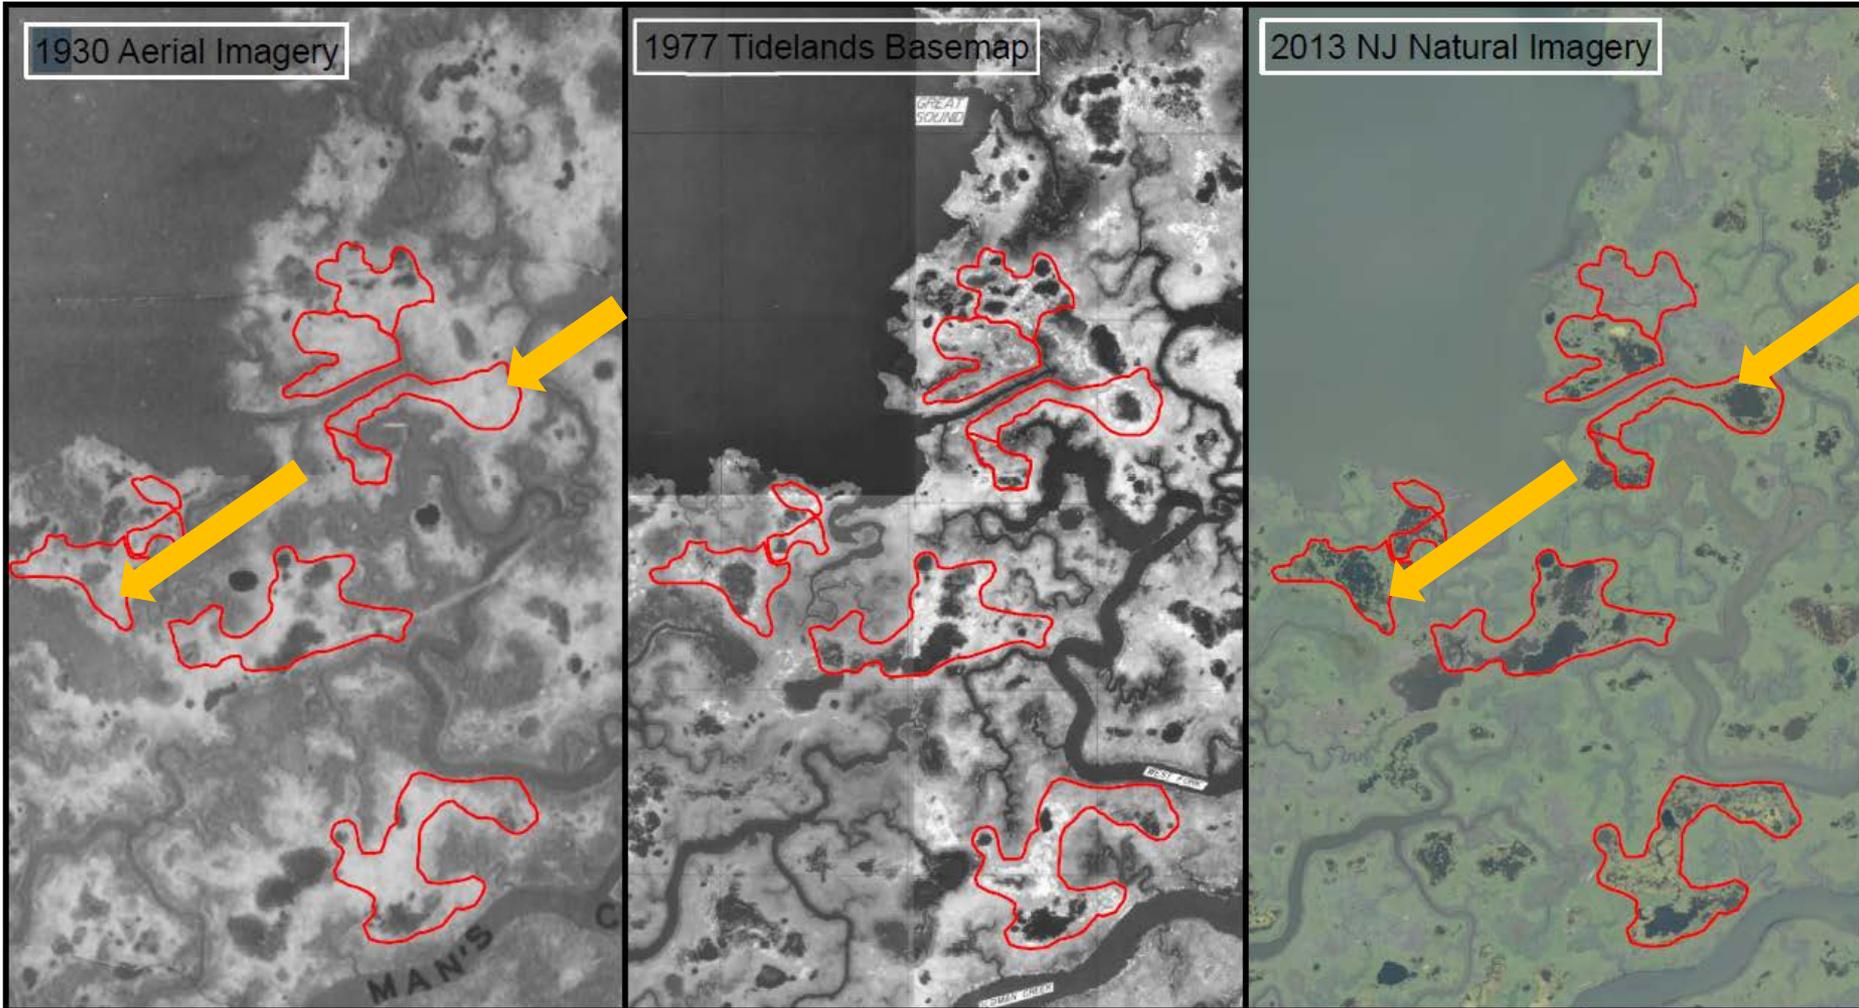
Desktop analysis: Historic Aerial Images

Avalon Marsh Restoration
Historic Aerial Images

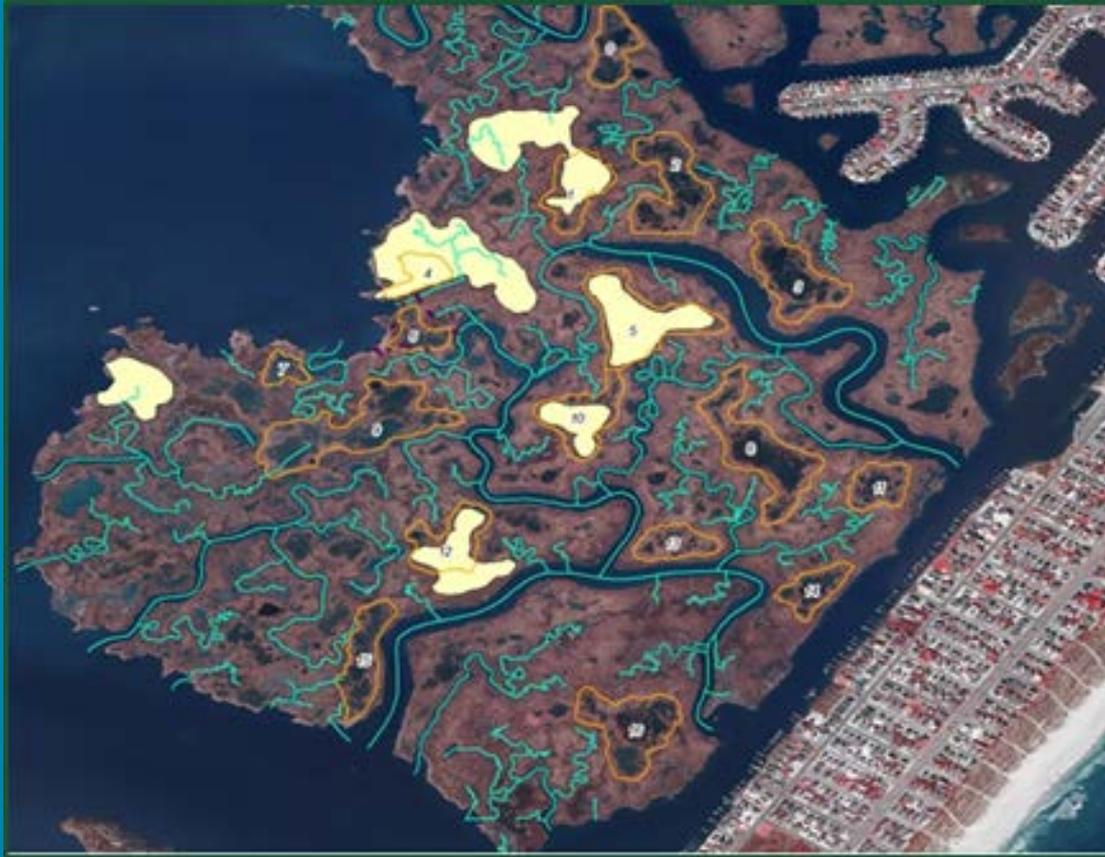
Drainage analysis to look at non-draining and poorly draining pools (outlined in orange)

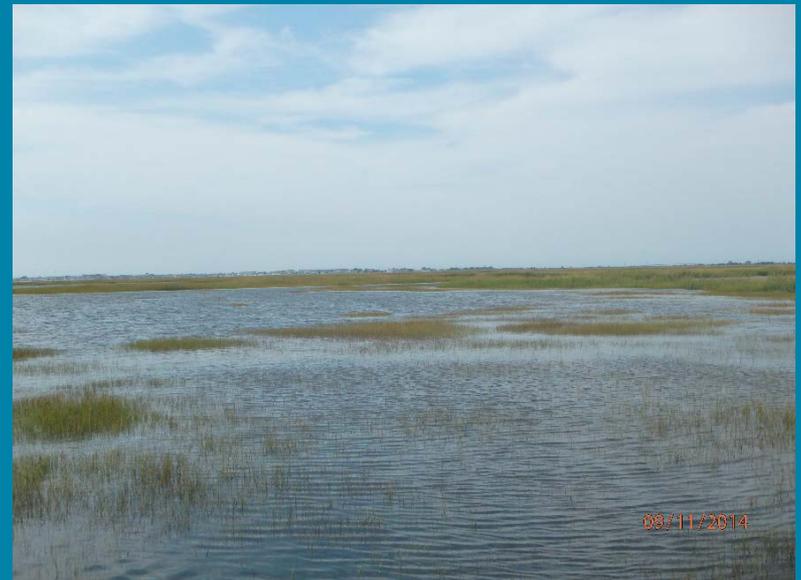
High tide over the marsh plain

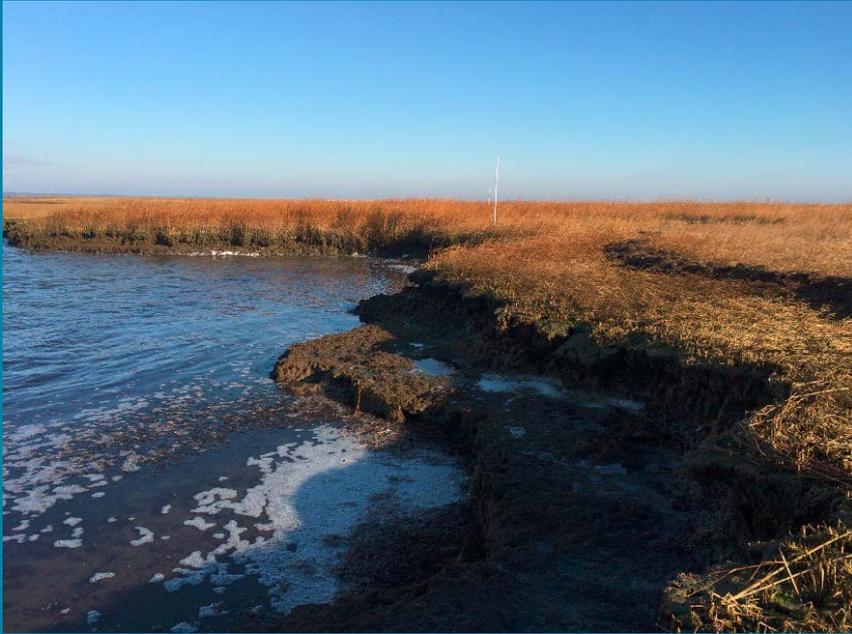
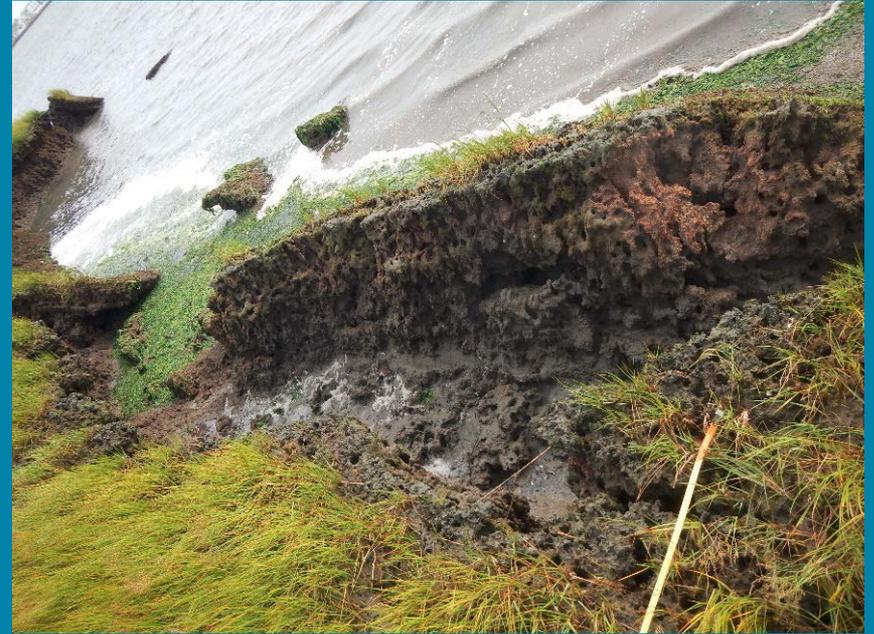
Extreme edge erosion

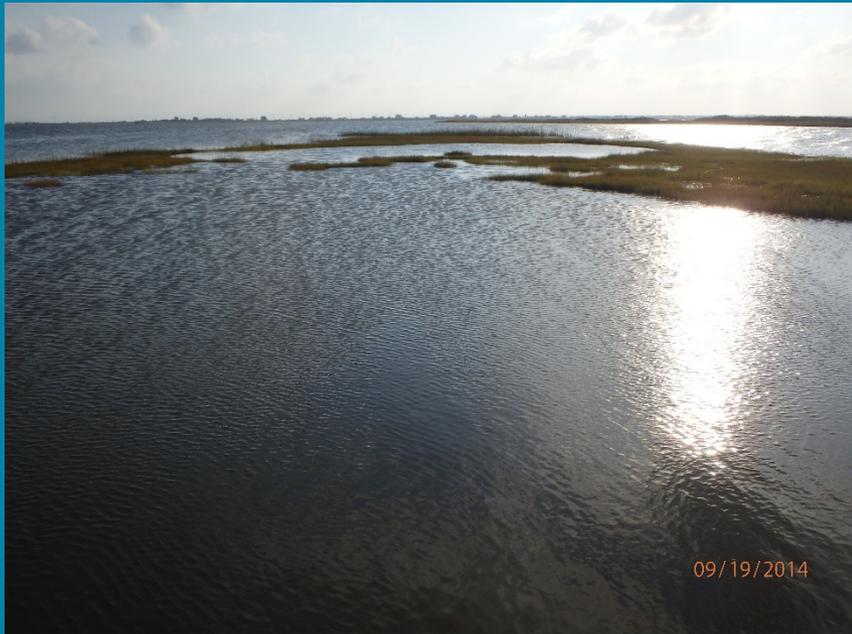
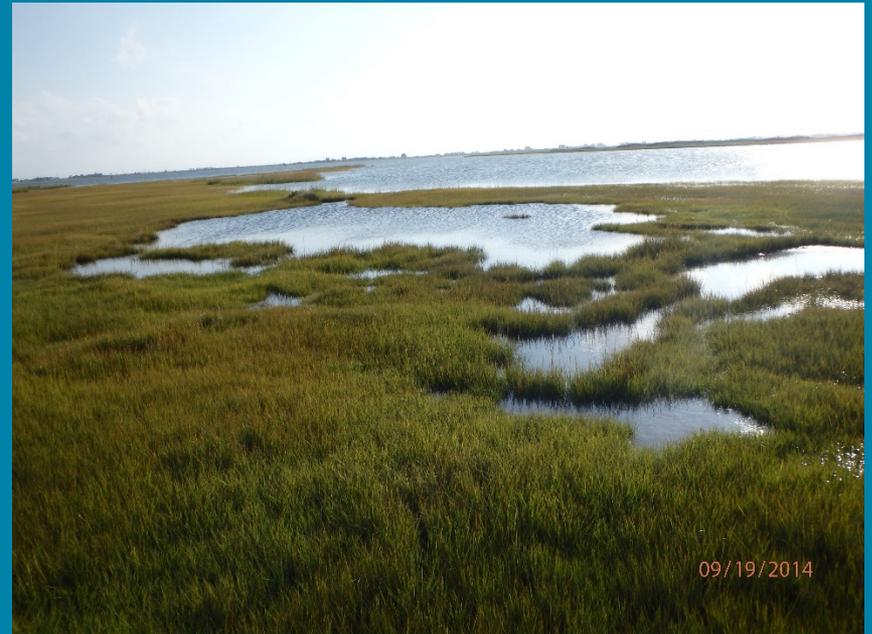
Expanding pools next to eroding marsh edge = blowouts

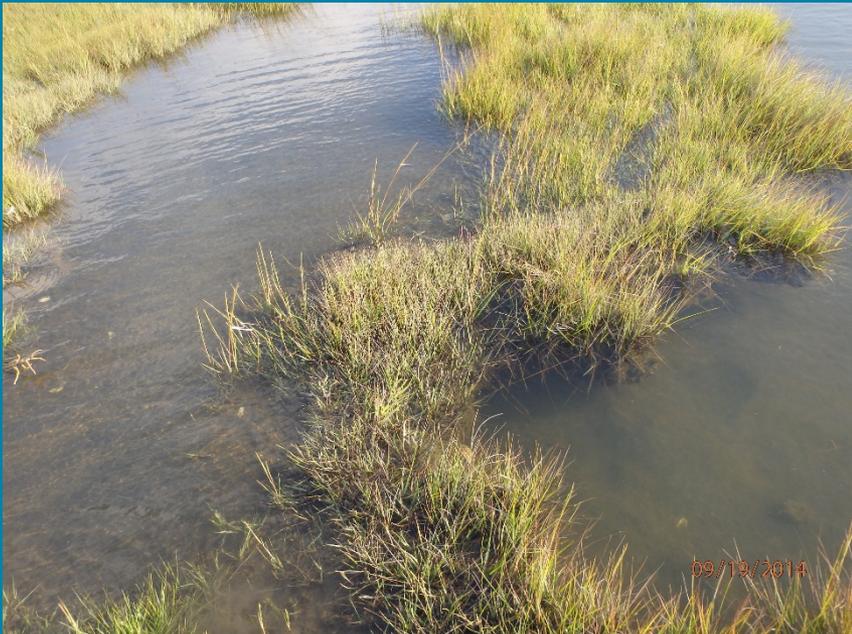
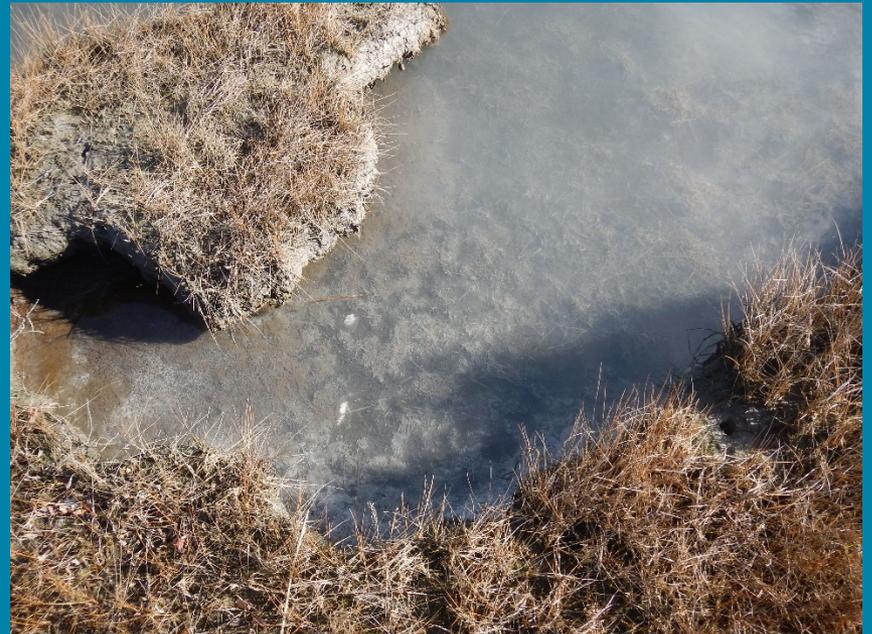
Expanding Pools and Unstable Platform

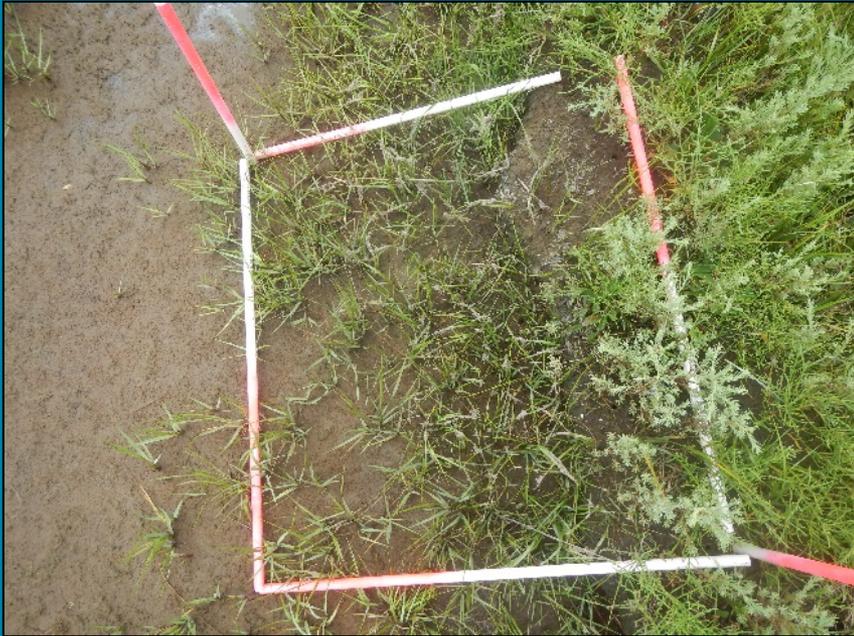
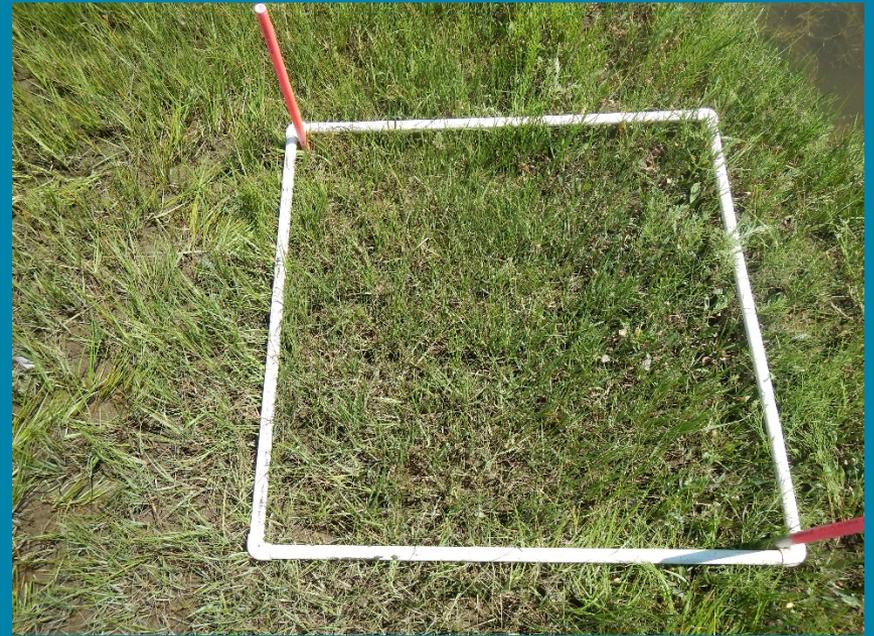
Vegetation: Stunted and sparse *Spartina alterniflora*

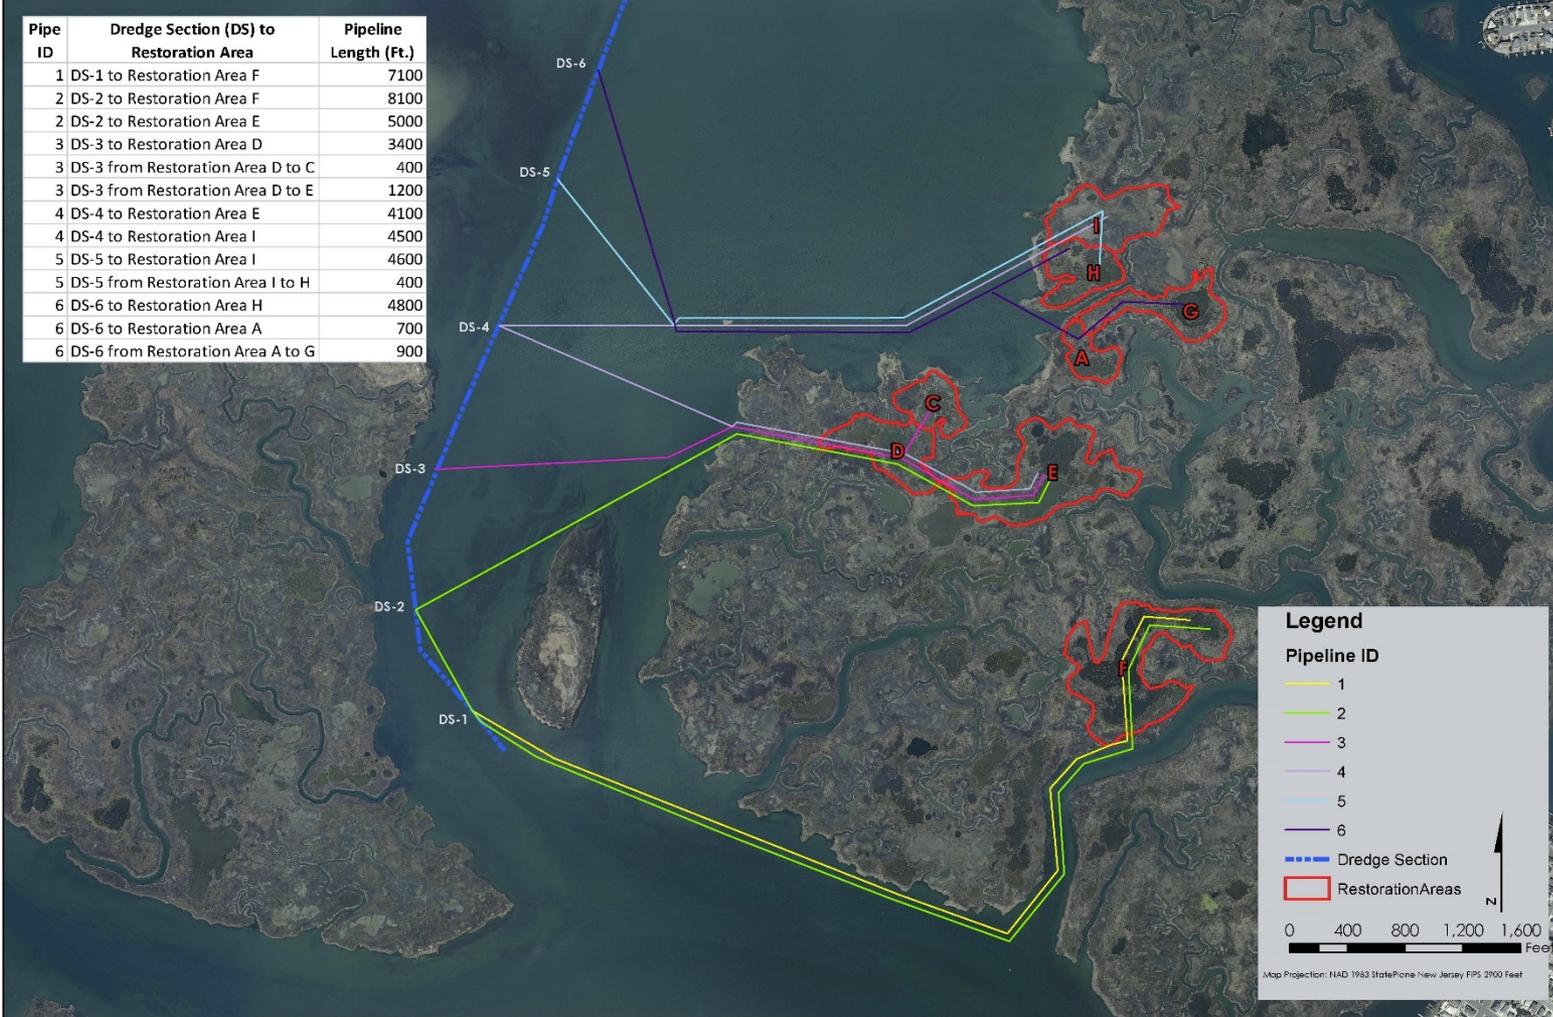
**THIN LAYER DREDGE
PIPE LAYOUT CONFIGURATION**
Avalon, New Jersey

Final Areas Selected for Placement
