Dam Removal Webinar Series

Part 3B: Rapid sediment analyses to inform restoration planning in Moodna Creek, New York

November 10, 2020

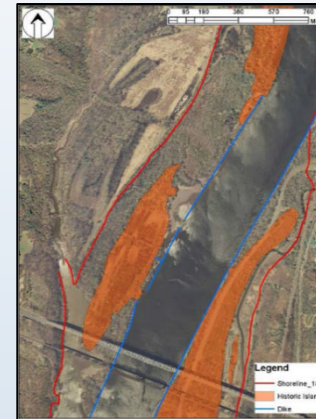
Lost Side Channels

- More than 85% of river side channels and islands were lost from dredging and filling
 - 28/29 side channels lost in upper portion of the study area
 - More than 70 miles of shoreline eliminated
 - 3,300 ac of wetlands lost
 - 700 ac of shallow water habitat lost
- USACE constructed longitudinal dikes and dams along the Hudson. Bulkheads and rip-rap were used to harden over 10,100 acres of shoreline (53%)
- More than 1,600 dams were constructed in the watershed disconnecting the river from its tributaries.

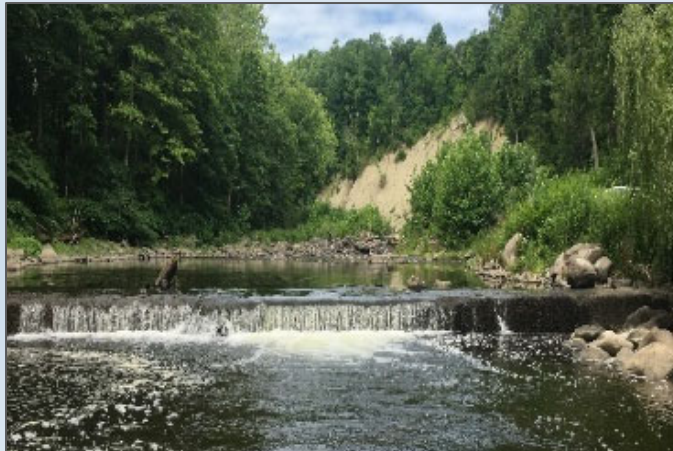
Barrier #1 Summary: Utility Crossing

- Structure height ~ 2 ft
- Max reservoir width ~ 65 ft
- Avg river width ~ 44 ft
- Description
 - Encased concrete sewer line (dormant)
 - Forms a weir with ~ 2 ft vertical drop
 - Full removal

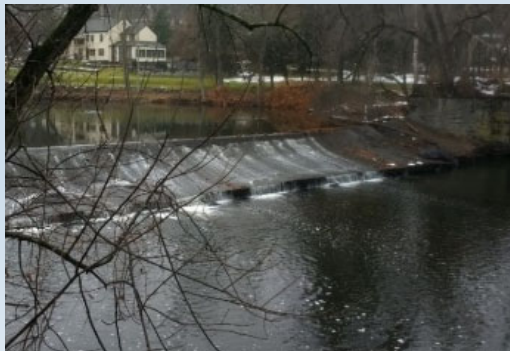
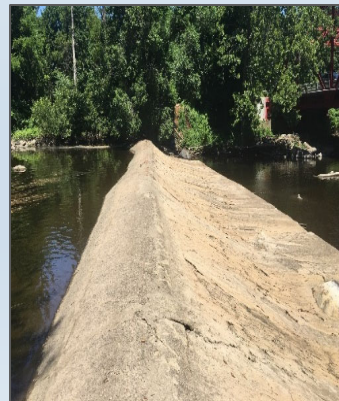
Barrier #3 Summary: Orr's Mill Dam

- Structure height ~ 10 ft
- Max reservoir width ~ 87 ft
- Avg river width ~ 60 ft
- Description
 - Concrete encased cobble-filled crib structure
 - Prior NYSDEC inspections characterized as being in a state of disrepair, structurally unsound, and “could fail at any time.”
 - Partial removal
