# HALF MOON REEF RESTORATION

## Restoring Form and Function of a Historical Reef in Matagorda Bay

Mark Dumesnil, The Nature Conservancy

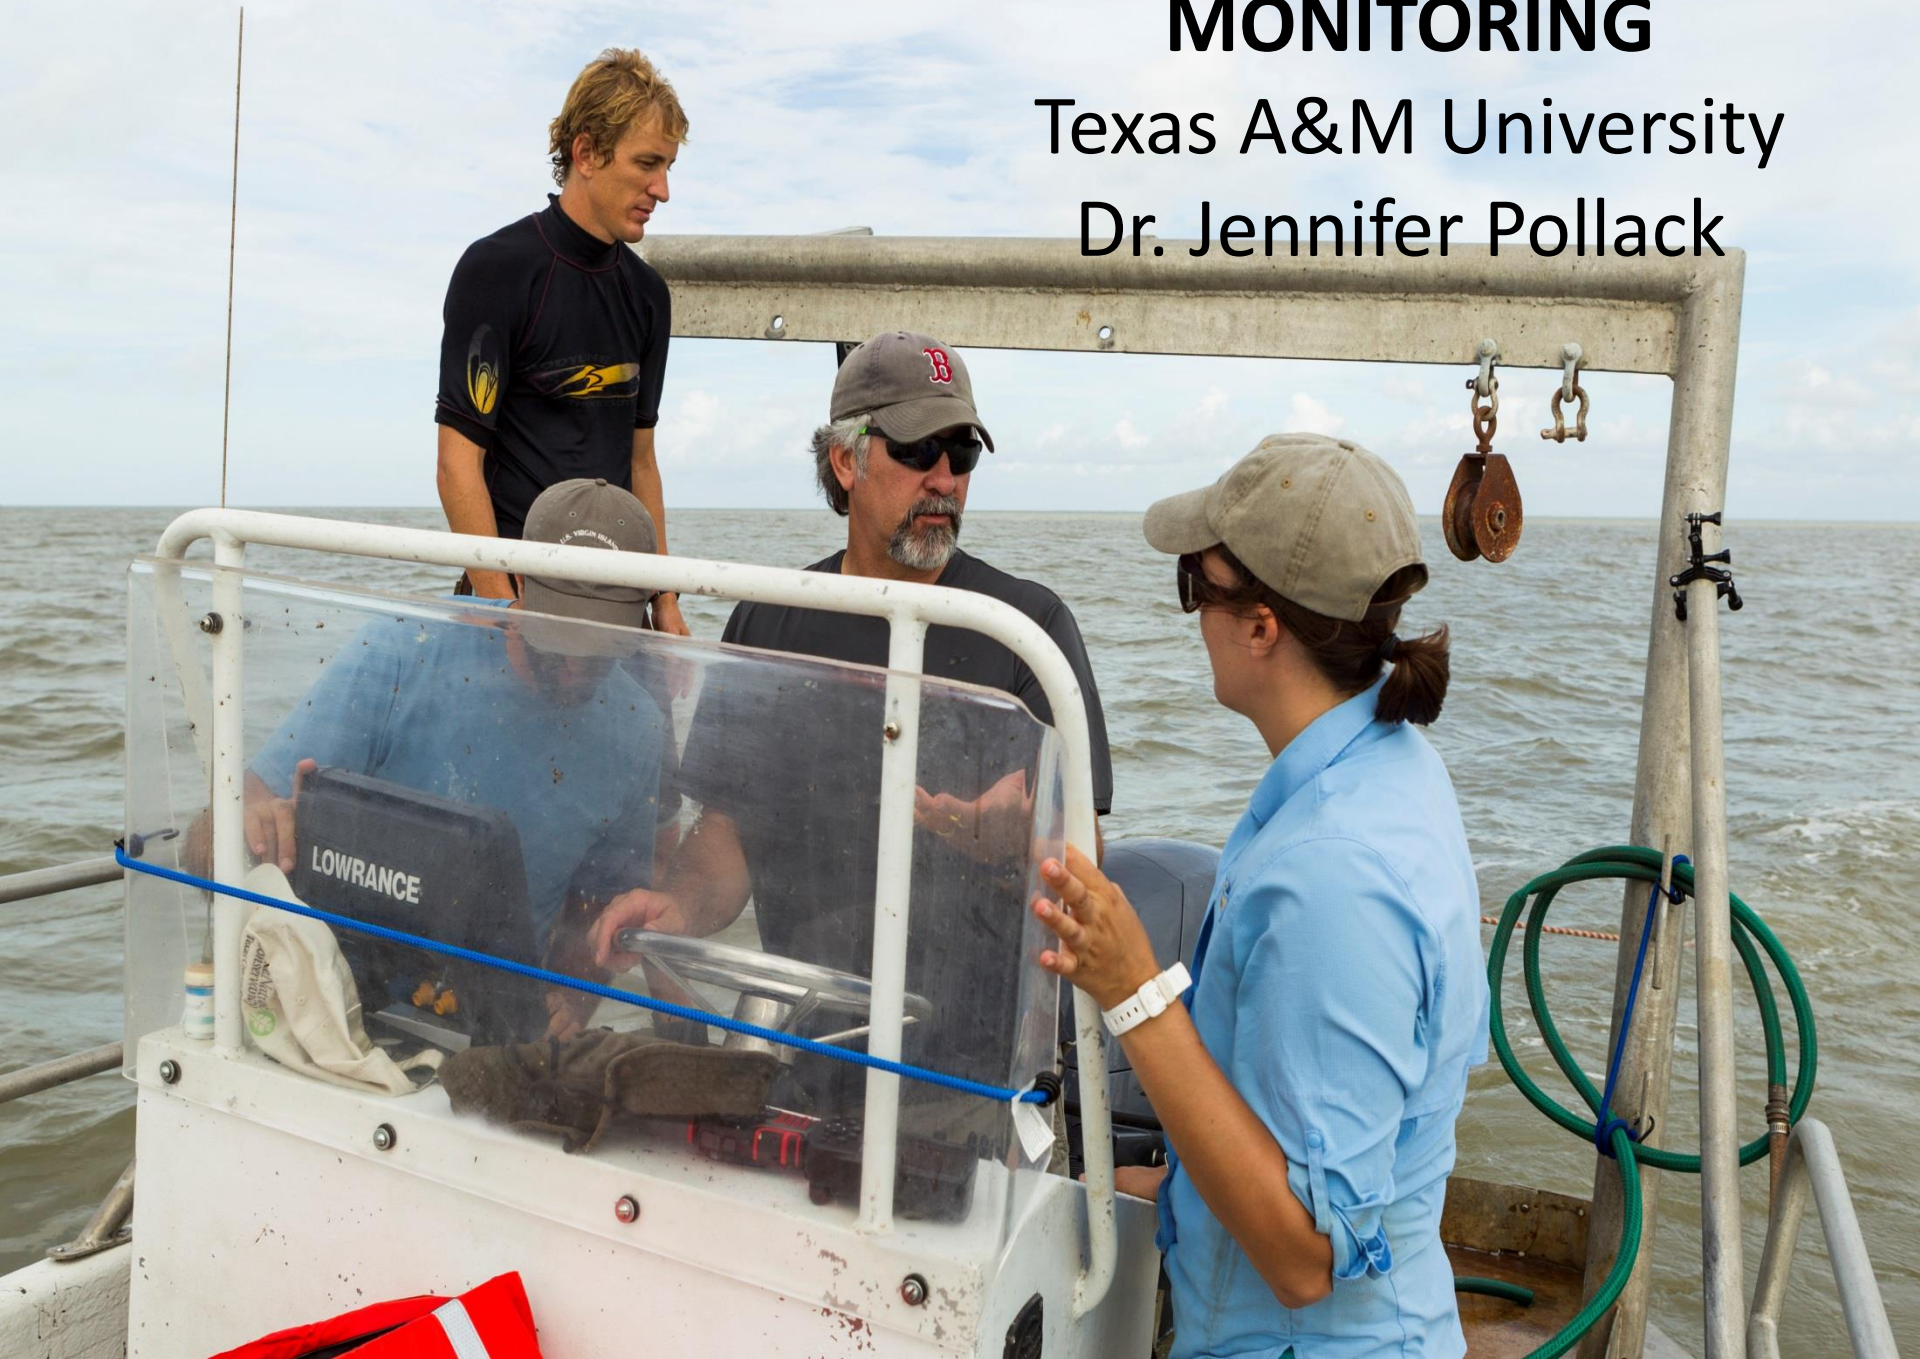
## INITIAL REEF SURVEY 2009

SHELL HASH  
HARD SAND

NW Permit NE Permit

SW Permit SE Permit

USACE Permit  
SWG-2012-00305  
356 acres

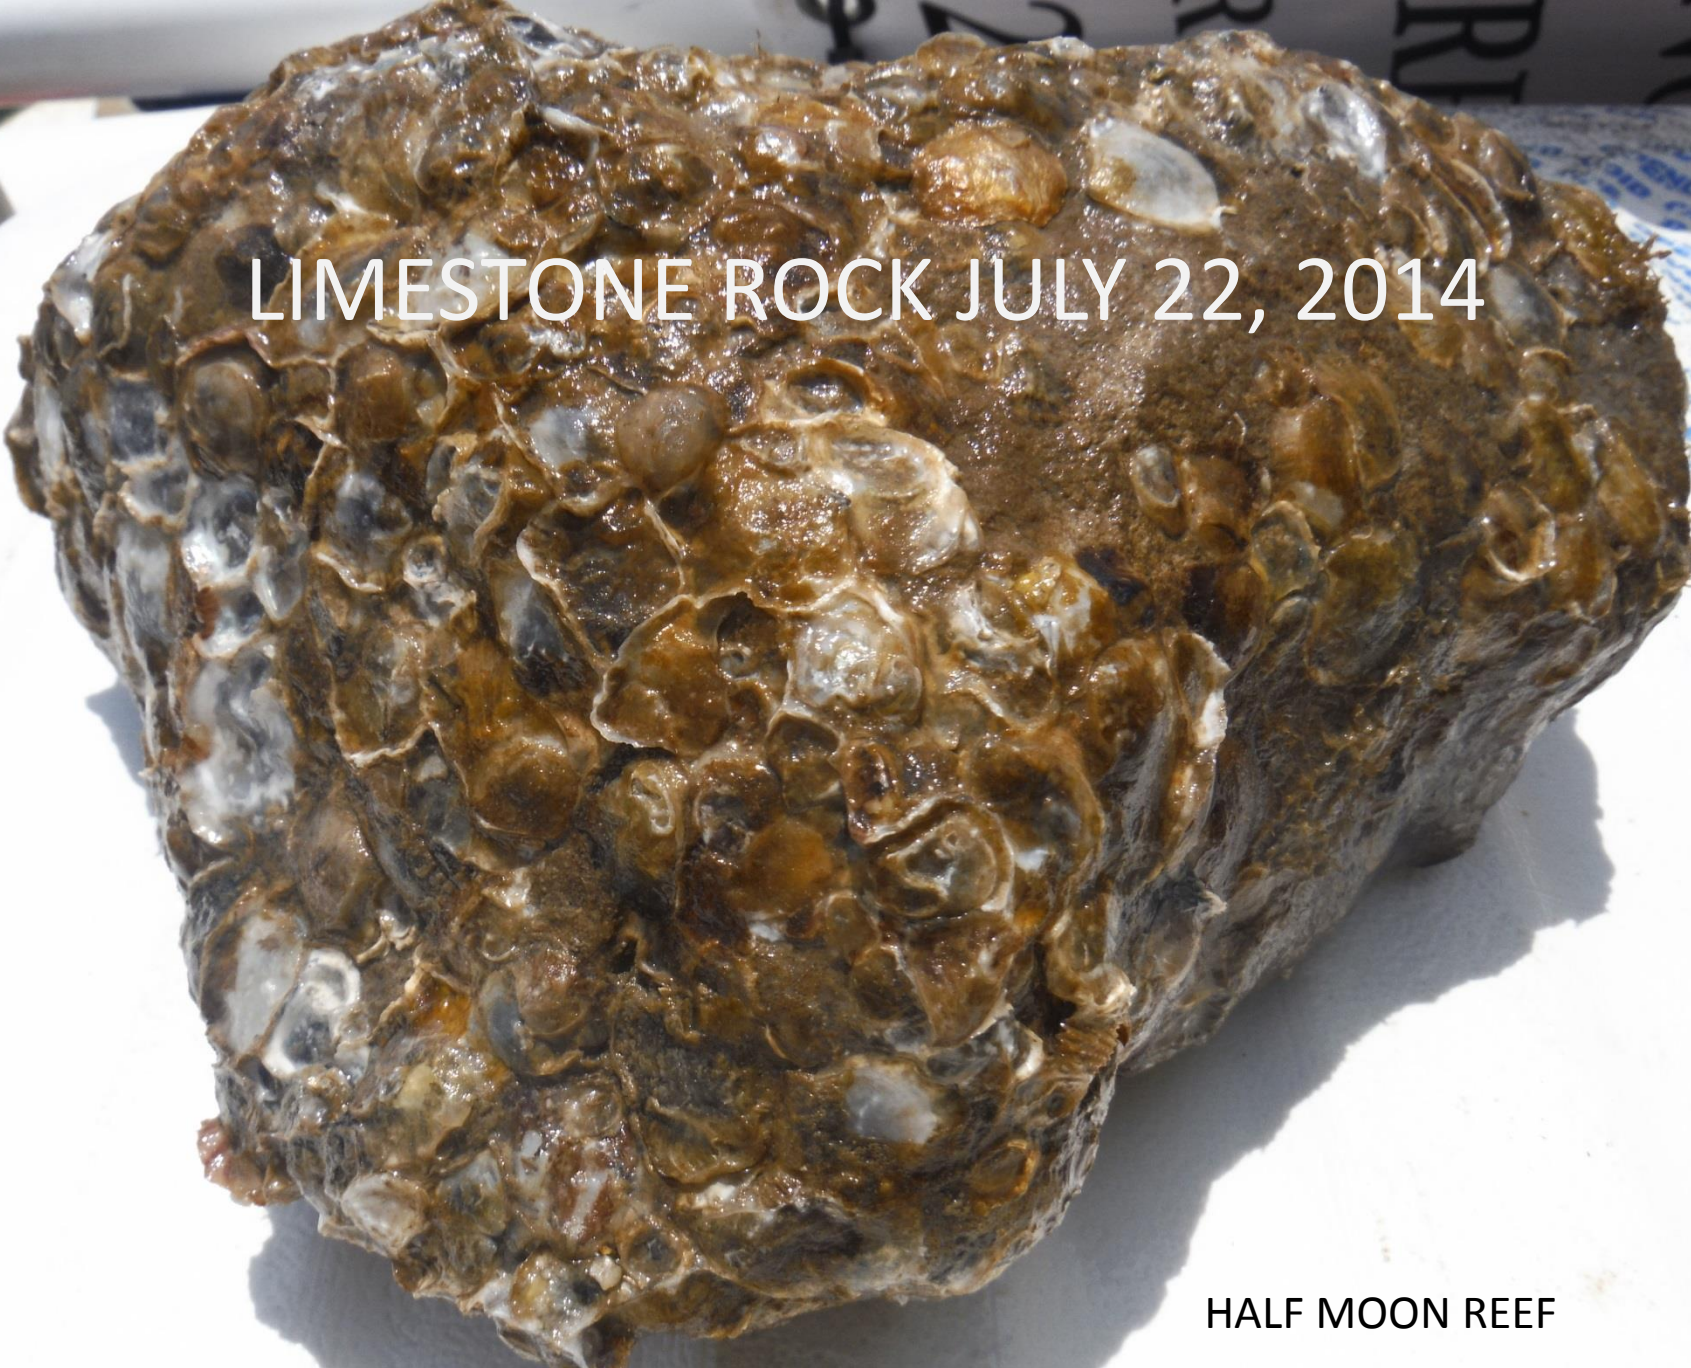
LIMESTONE ROCK JULY 22, 2014

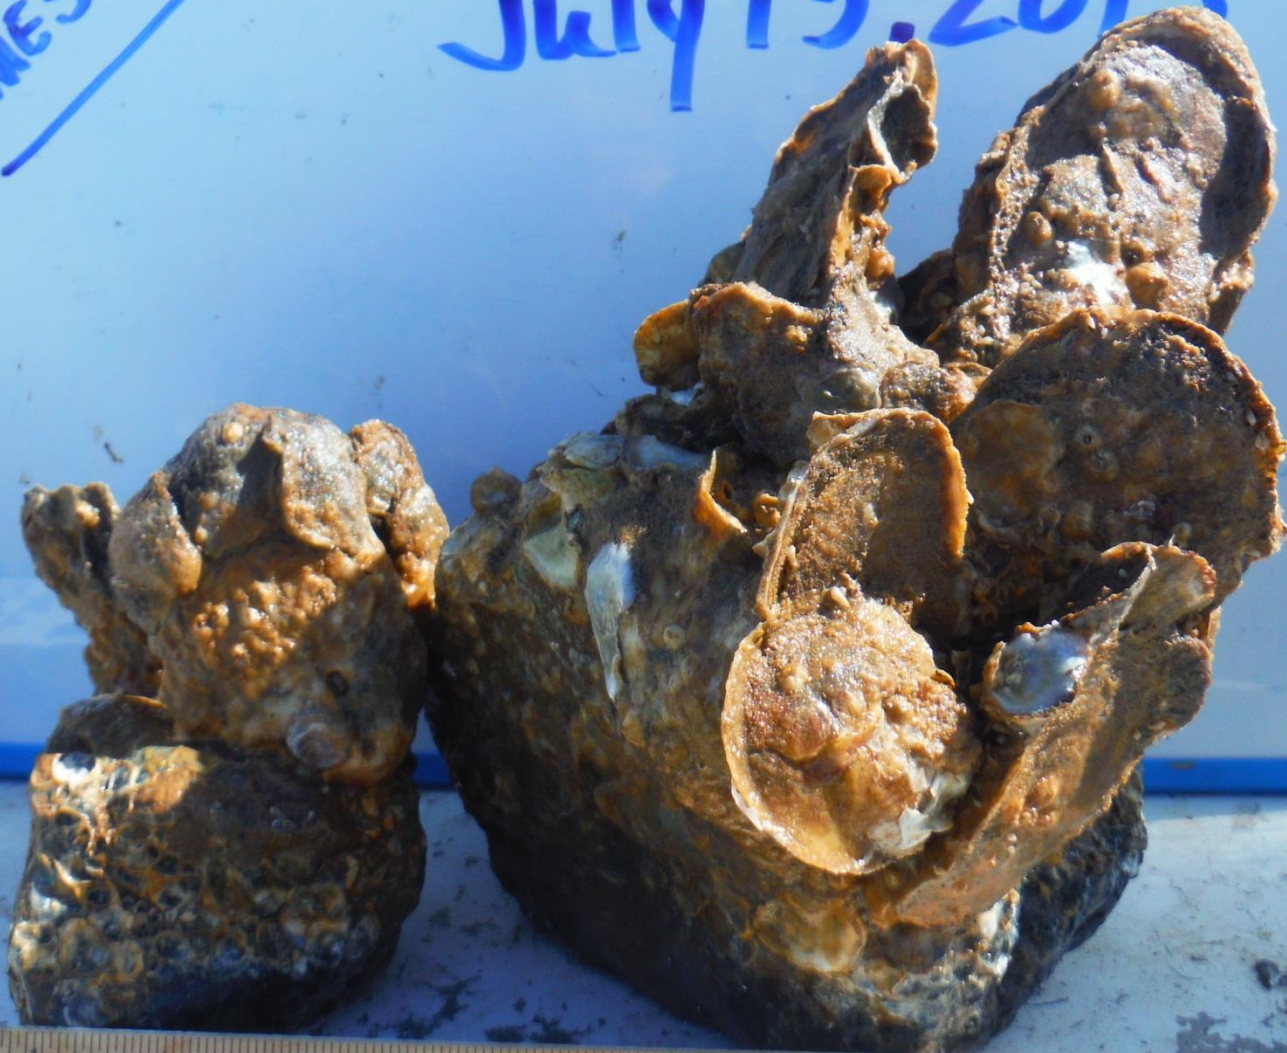
RECYCLED CONCRETE JULY 22, 2014
